# PROSSER AIRPORT

## 2005 PAVEMENT MANAGEMENT REPORT

**February 2006**

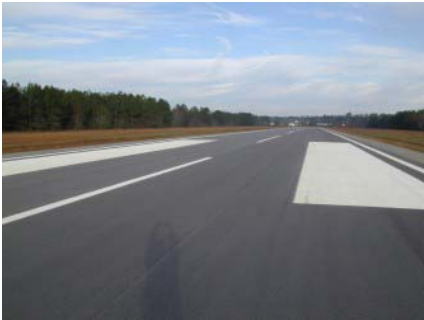
100

Representative Pavement Surface <sup>1</sup>	PCI
